109 peckham high street

NAME THE GREYHOUND

DATES. 2020 - 2021

CLIENT. SOUTHWARK COUNCIL

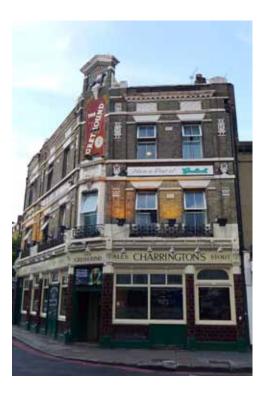
right: The Greyhound Public House in 1979 - Southwark Local History Library and Archive

left: 109 Peckham High Street in 2018 before works and in 2021 after works

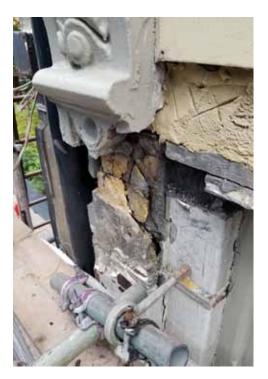
Further close up investigations of the existing tile work at lower level also revealed the need for more extensive opening up works as fractures in the pilaster face indicated the movement of it away from the building fabric was due to larger underlying problems. These opening works concluded it was not a structural issue and was due to failing patched render attempts over the years. As a result, stripping back and restructuring the backing and facing with match tiles restored the fine details to this part of the facade and reduced any risk to the general public.

above: investigation works to the missing pilaster head and face prior to redecoration and tile works right: replicating the fascia tiles and decoration works to the lead windows My advice is that all plugs or other expanding devices intended to secure screwfixings in the wall be removed by careful drilling out. Infilling mortars should be proprietary Keim repair mortars."

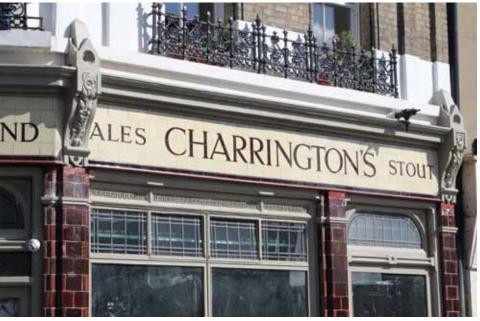
Following the success of the stain glass restoration work in phase 1, we reused the same subcontractor to undertake the restoration of the simple yet striking stain glass fan lights that were above the ground floor windows. There was several fanlight panes that were broken and disfigured with vents, ad-hoc repairs and as result required careful remediation and replacement off site. Once brought back to site they looked as if they had always been in such great condition which added to the property's mystique.
