## 86 peckham high street

NAME: **ACUHERBAL**  
DATES: 2018 - 2021  
CLIENT: SOUTHWARK COUNCIL  
SPONSER: HERITAGE LOTTERY FUND  
MAIN  
WORKS: **RESTORE**

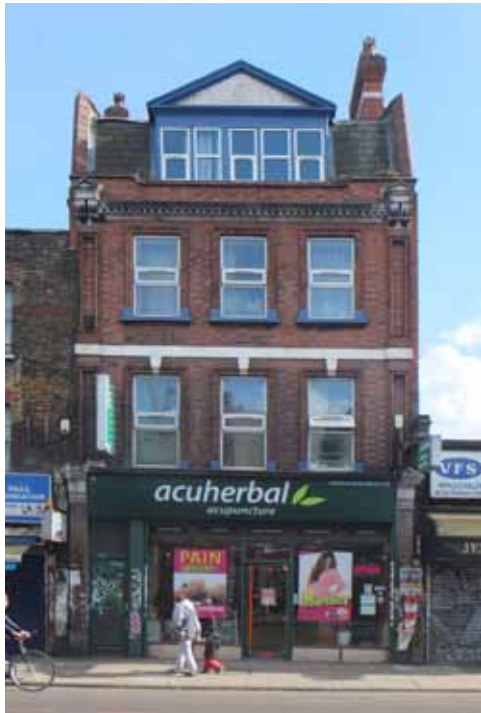
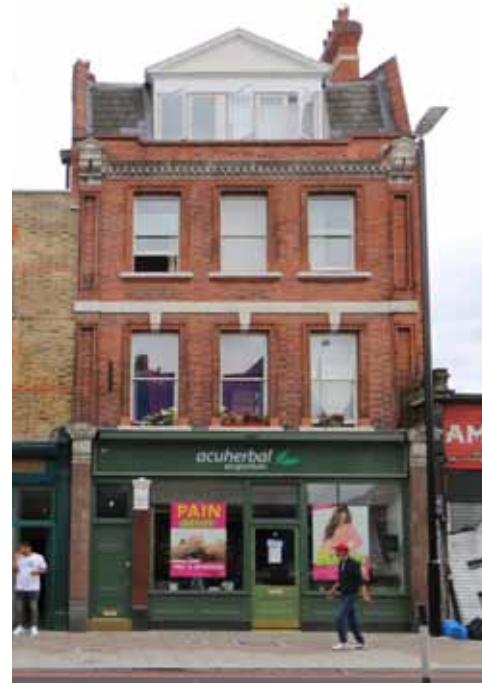
**right:** 86 Peckham High Street in 1979 - Southwark Local History Library and Archive

**left:** 86 Peckham High Street in 2017 before works and in 2021 after works

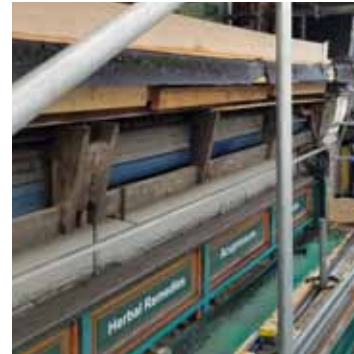
above: restoration works to the Portland stone capitals  
right: upclose view of the new shopfront features as a whole

Further down, the plain stone band and the head of the first floor window keystones were stripped of flaking paint alongside the blue sills and corner stones using nonabrasive cleaning. Where necessary, delicate repairs to the stonework was undertaken by a suitably experienced and expert specialist to use a crack stitching method which is invisible once installed and therefore did not disrupt the aesthetic
