88 peckham high street

NAME	MAMA
DATES	2018 - 2021
CLIENT	SOUTHWARK COUNCIL
SPONSER	HERITAGE LOTTERY FUND
MAIN	
WORKS	RESTORE
	BRICKWORK
	TIMBER WINDOW FRAMES
	HANGING SIGN
	PILASTER FACE/PEDESTALS
	CONSERVE
	PILASTER HEADS
	GAUDGED LINTELS
	REPAIR
	PITCHED ROOF
	LEADWORK + DRAINAGE
	REDECORATE
	SILLS
	SHOPFRONT
	DECLUTTER
	CABLES AND PARAPHERNALIA

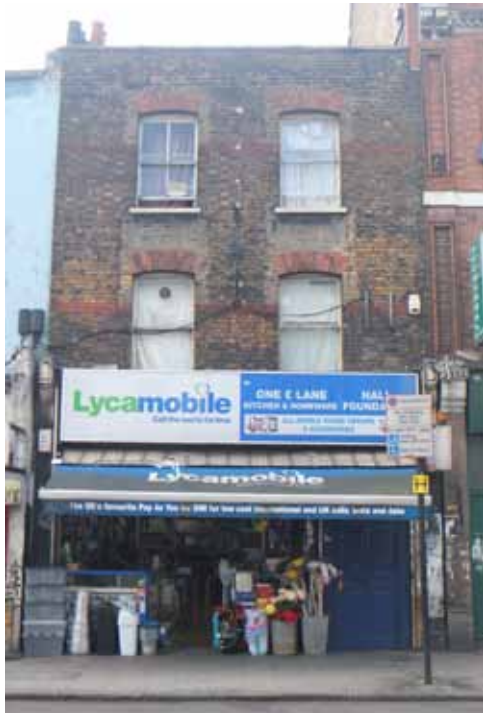
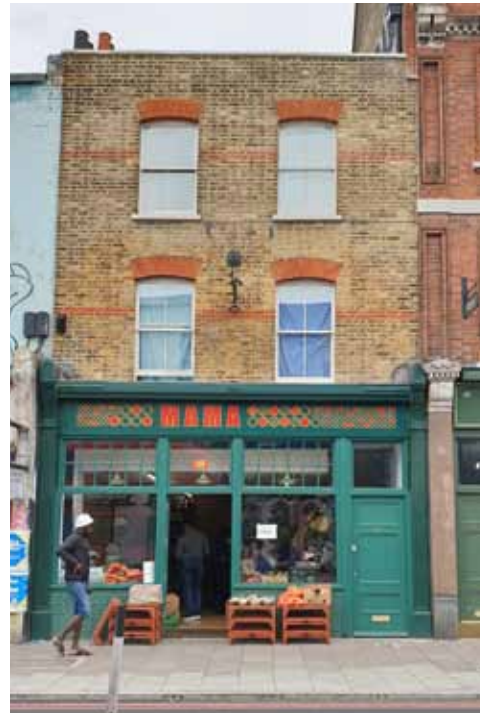
There has been previous movement of the front wall which has been repaired by the addition of a pattrass plate and second hand brickwork stitching at 1st floor. Inappropriate cement patches in a vertical line on the façade related to alternative fixings and require attention to realign and marry the brickwork elevation.

left: 88 Peckham High Street in 2018 before works and in 2021 after works

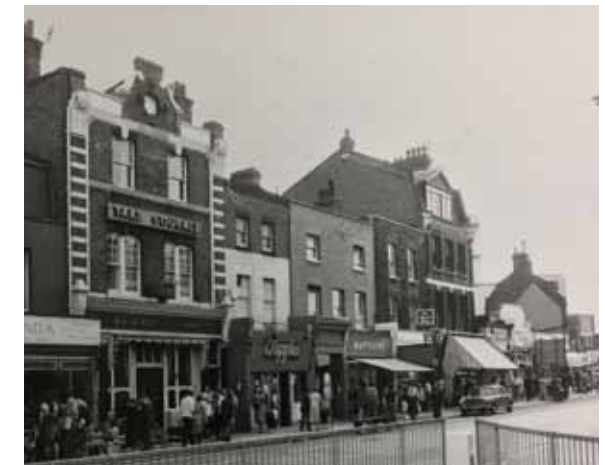
right: 88 Peckham High Street in 1979 - Southwark Local History Library and Archive

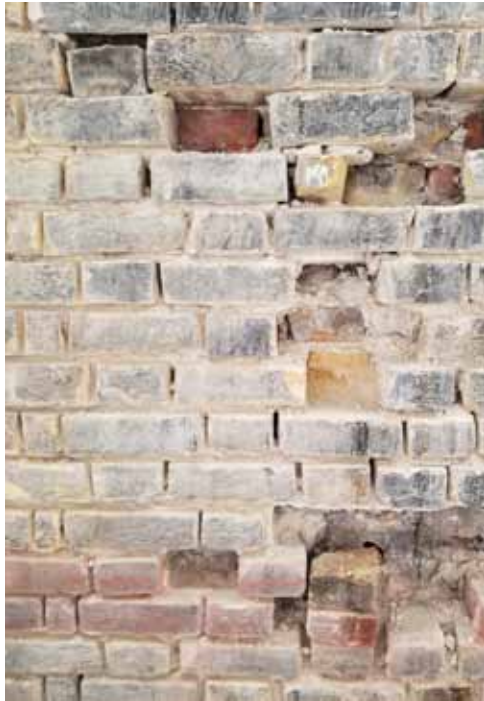
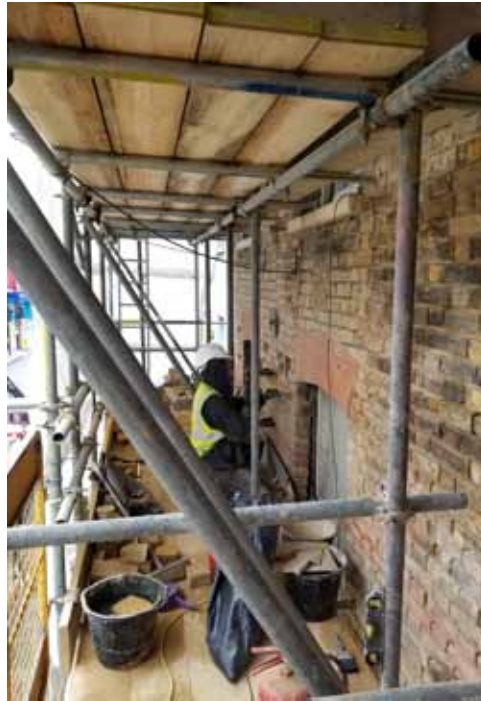
Structural repair undertaken within the last 30 year to stabilise the front wall and parapet has disfigured the main elevation by disrupting the intended pattern, surface colour, texture and bond of the facing brickwork. Cement mortar, which does not permit release of water-vapour from backgrounds, has been used to bed and joint brickwork in these recent repairs. As a result after undertaking a close up brickwork survey it was returned to a state where the facing brickwork was consistent and entire. Cement mortar was carefully cut out and replaced with "vapour-open" bedding and jointing mortar made with a lime binder. However, the pattress plate for the steel tie was retained as this constitutes evidence of what has happened to the building over time.

“ **Cement mortar is to be carefully cut out...however, the pattress plate for the steel tie will remain as this constitutes evidence of what has happened to the building over time.**”

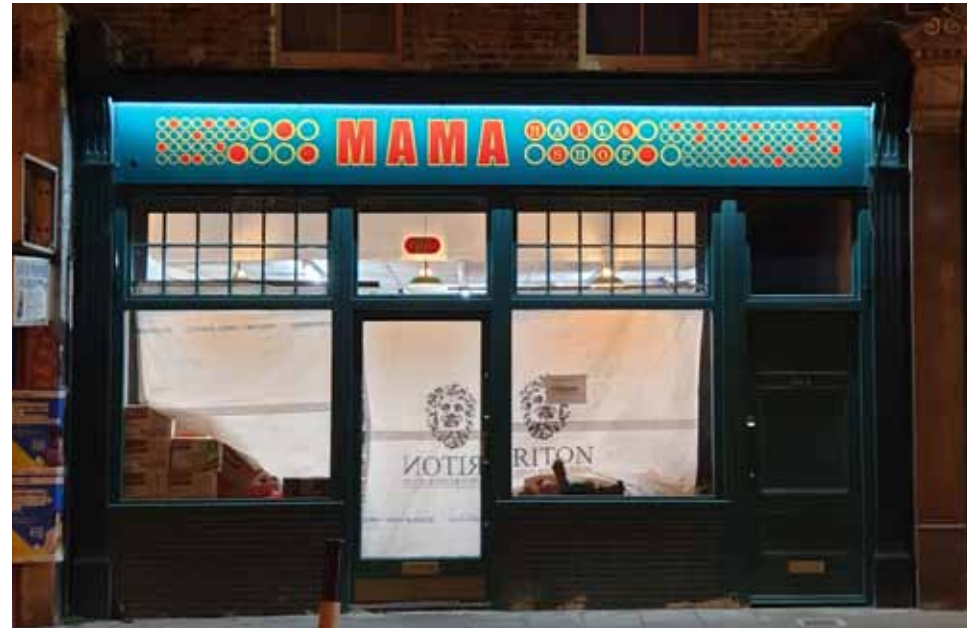
above: restoration works to the Portland stone capitals
right: upclose view of the new shopfront features as a whole

We removed the existing fascia and layers of ad hoc paraphernalia from the floor, walls and ceiling to allow for a new shopfront insertion. Due to the historical basement below the projecting shopfront required additional structural works to built it off an upstand footing and be braced at the top between both brickwork peers. The existing pilaster heads were conserved using timber repair care resin so as to be able to reinstate a timber fascia and cornicing with an electronic operating Victorian awning to suit.
