119 peckham high street

NAME **THE OLD CROWN HOTEL**

DATES 2017 - 2019

CLIENT SOUTHWARK COUNCIL

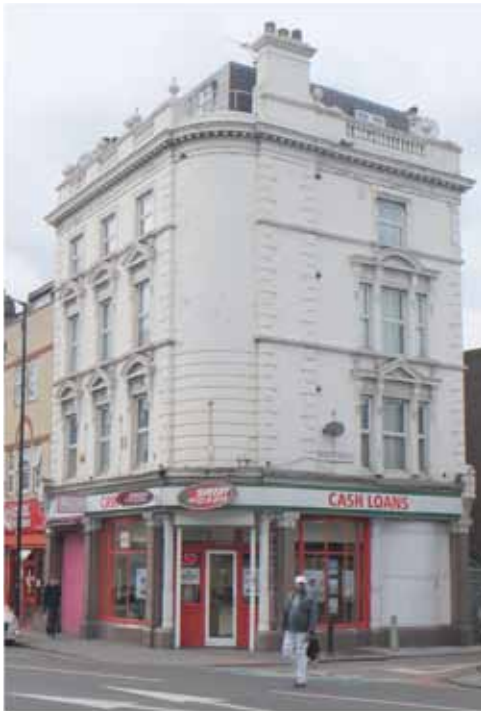
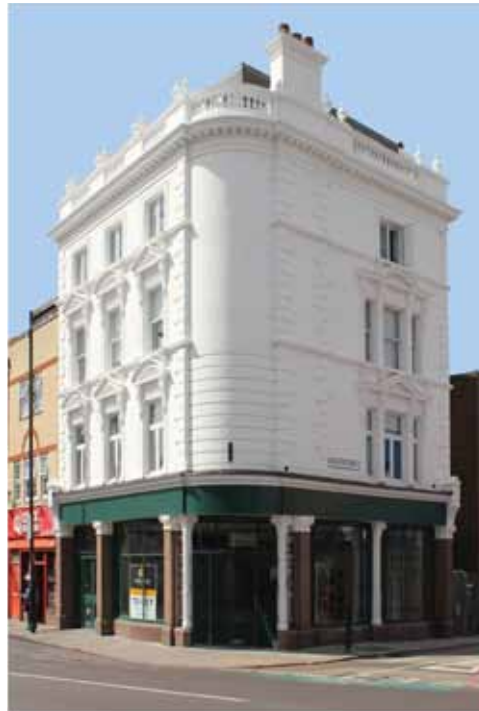
right: The Crown Public House in 1905 - Southwark Local History Library and Archive
left: 119 Peckham High Street in 2017 before works and in 2019 after works

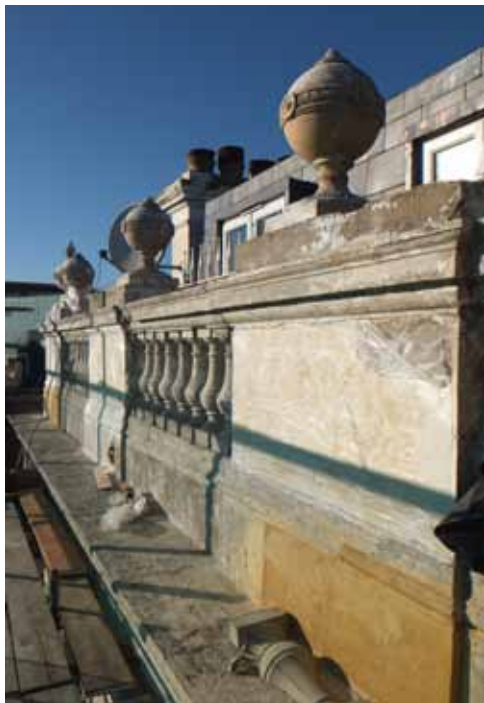
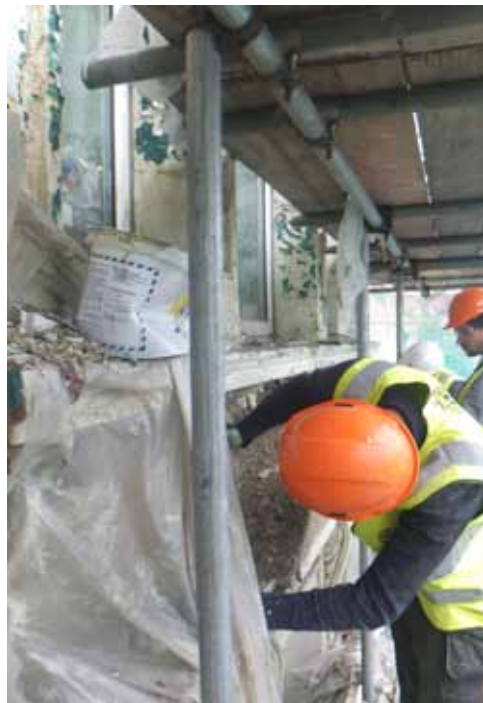
For example, this SPAB principle was applied to the heavily modelled, richly ornamented upper facades which asserted the buildings presence on the main street. The condition of the modillioned upper cornice and elaborate parapet balustrade ornamented with urns was visibly incomplete and 'quick fix' methods had considerably altered its appearance. By removing these interventions and repairing or replacing missing urns and baluster bottles it re-established the grandeur nature of this part of the building whilst respecting the fourth floor roof top extension.

The pediment window surrounds on this building are both strident and distinctive, as are the rusticated quoins on the corners. The condition of them had been affected by damp emanating from defective flashings and several layers of paint which had allowed water to expand and contract creating several defects. Before the facades were redecorated, all the defective fabric behind the paint was repaired and

above: restoration and redecoration works to the parapet balustrade finials and stucco facade painting stripping
right: replicating the shopfront leaded light window pane details upon discovery of original artefacts

made weather-tight. Infilling mortars used was Keim Spachtel. At the same time, new sash and casements windows were fabricated to fit carefully into debricked openings. Together the final arrangement better reflects the elegance of the facades distinctive architectural features. A reinstatement of a gate to the corner elevation replaced an ad hoc external shutter. There was a gate prior to this when looking back at the historical pictures. However, as we didn't have any more detail on the historical gates, we simply made them look unobtrusive and curved to suit.

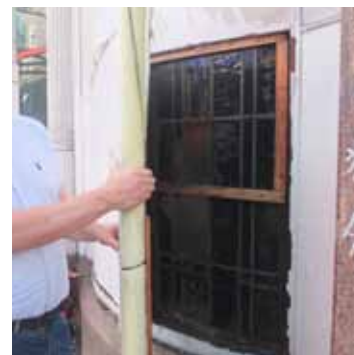
A new timber shop-front and entrance door to the corner of the building was fabricated to suit the original proportions of the existing timber windows to the main and side streets. Once on site, the far end shopfront window was uncovered for the first time and a damaged but surviving stain glass detail was found. This was used to prepare replica design & wording for new stained glass panels which several residents and other members of the public have developed great affection and regard for.
