## 102 peckham high street

NAME	SHOE REPAIR SHOP
DATES	2019 - 2021
CLIENT	SOUTHWARK COUNCIL
SPONSER	HERITAGE LOTTERY FUND
MAIN	
WORKS	<b>RESTORE</b> DORMER TIMBER WINDOW FRAMES AWNING PILASTER FACE/PEDESTALS <b>CONSERVE</b> EAVE ALIGNMENT <b>REPAIR</b> PITCHED ROOF DRAINAGE LEADWORK + FLAUNCHING <b>REDECORATE</b> PARAPET SHOPFRONT <b>DECLUTTER</b> CABLES AND PARAPHERNALIA

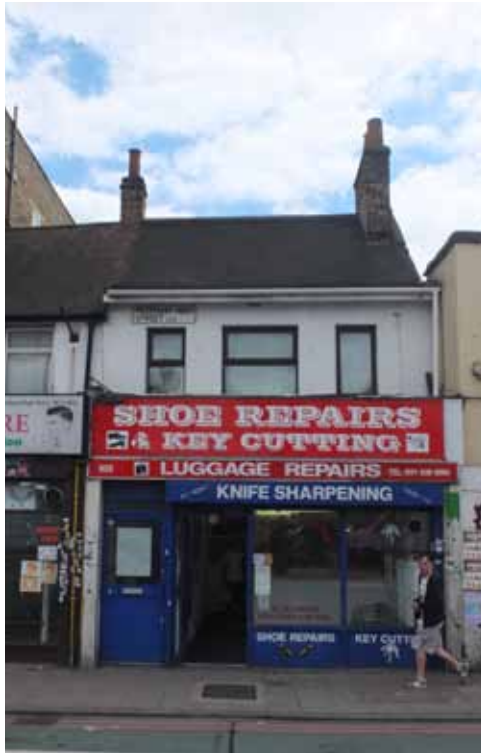
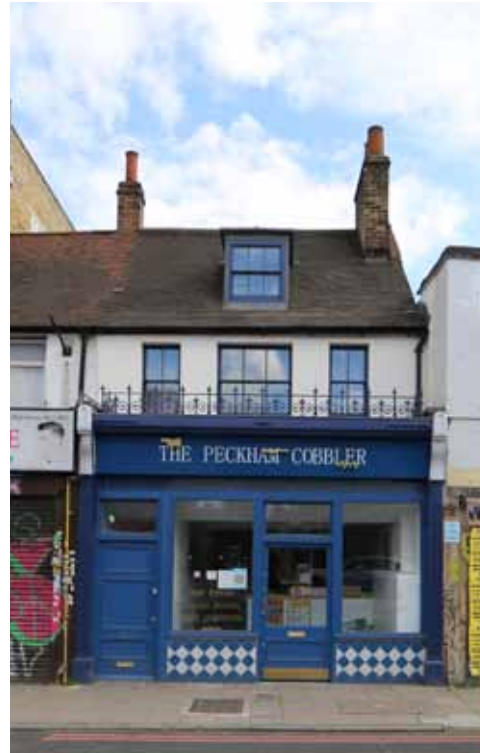
In 2018 we observed the front elevation of the property was severely degraded and architecturally diminished compared to its appearance in the earliest of the surviving historical photographs dating abck to 1928. However, a later 1945 photograph provides some explanation for the loss of original distinctive features and ornament. The shattered shop front at street level is almost certainly the consequence of war-time bomb blast damage and a subsequent shopfront was installed. The photograph also shows that the shop has been incorporated into the retail area of the neighbouring premises up to number 106. The three shops were amalgamated into one trading outlet, such that it had become an annexe to the main business premises there. In this way later on when relinquished from this, there was no effort or expense devoted to restoring the decorative features of the original shop-front as seen in photograph taken in 1979.

**left:** 102 Peckham High Street in 2019 before works and in 2021 after works

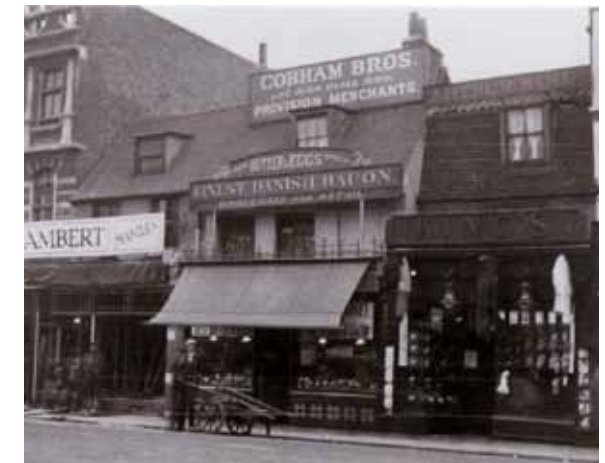
**right:** 102 Peckham High Street in 1928 - Southwark Local History Library and Archive

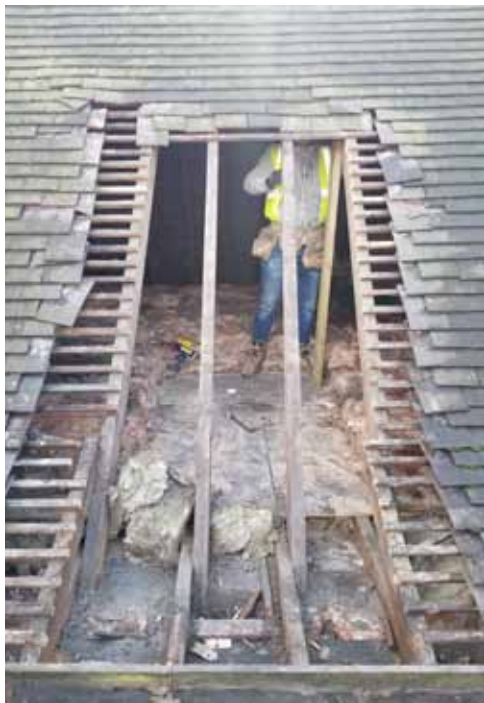
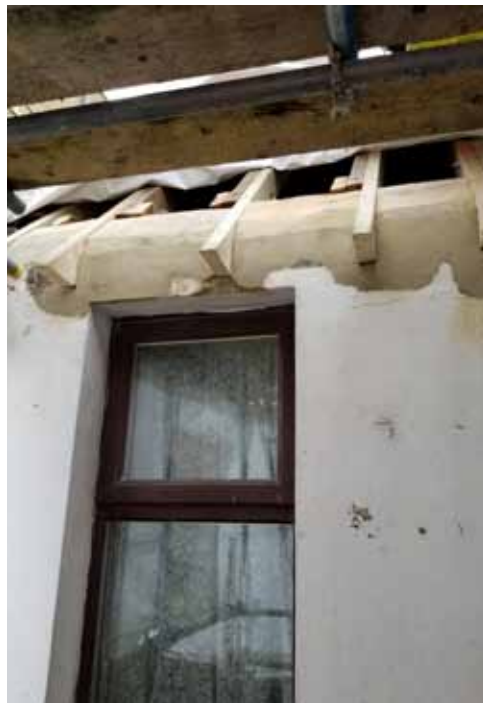
The recent condition to keep the building functioning had been entirely pragmatic and utilitarian. As a result, we addressed releveling the adjusted eaves level surface water drainage from the roof, the reinstatement of the dormer and timber pilaster heads, redecoration of the cement render, complete overhaul of the projecting roof top and drainage.

**above:** restoration works to the pitch roof dormer and eave alignment  
**right:** upclose view of the new shopfront features as a whole

A historic building conservation principle is that, having been irretrievably lost, missing ornament or other, once important, architectural features cannot be put back because no evidence remains to inform the correct detail design for the reinstatement. However, it is permissible to study the "Pattern Books" and catalogues of contemporary manufacturers of materials for use in building conservation to search out products now available that are very close in their appearance to what has been lost. The cast iron panels intended for installation above the ground floor cornice are not exact copies of what were once

there, but the panel dimensions, panel centring and fretted design are all very close to the original.
