105 peckham high street

NAME	M.MANZE
DATES	2019 - 2021
CLIENT	SOUTHWARK COUNCIL
SPONSER	HERITAGE LOTTERY FUND
MAIN	
WORKS	RESTORE BRICKWORK TIMBER WINDOW FRAMES AWNING PILASTER FACE/PEDESTALS CONSERVE PILASTER HEADS GAUDGED LINTELS REPAIR PITCHED ROOF LEADWORK + FLAUNCHING REDECORATE PARAPET SHOPFRONT DECLUTTER CABLES AND PARAPHERNALIA

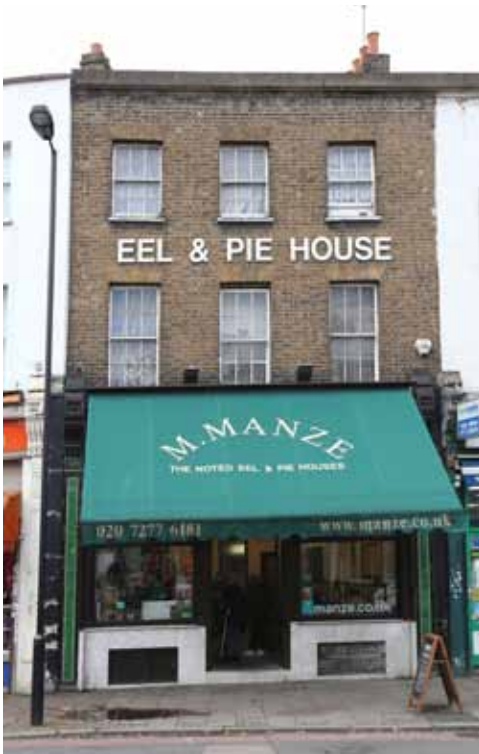
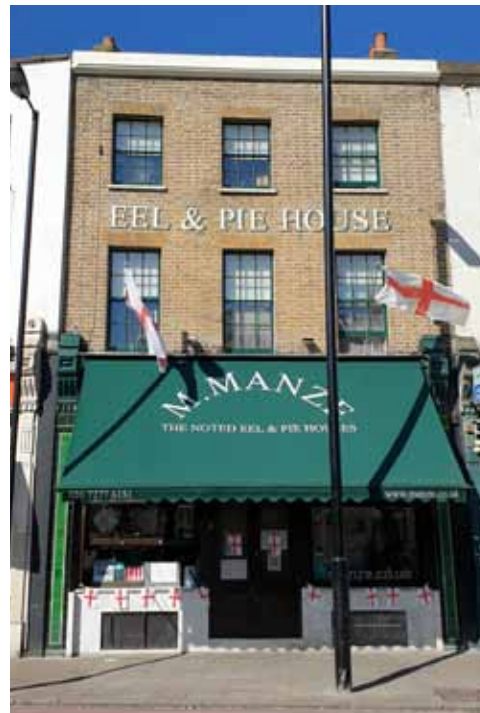
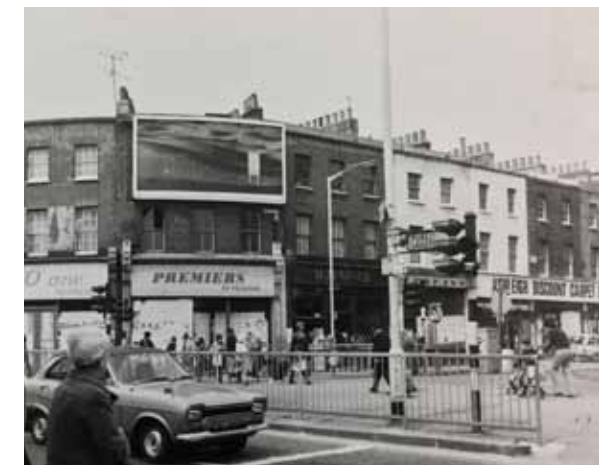
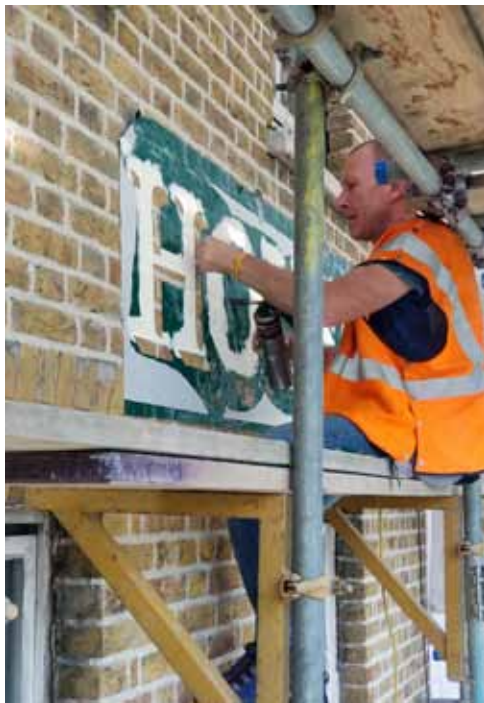
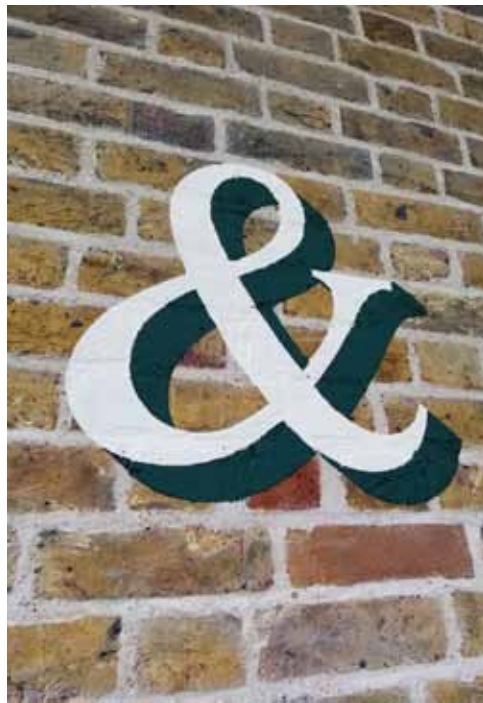
right: 105 Peckham High Street in 1979 - Southwark Local History Library and Archive

left: 105 Peckham High Street in 2019 before works and in 2021 after works

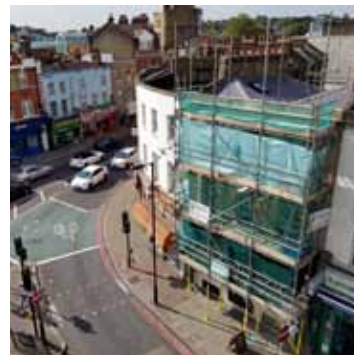
above: reinstatement of new signage using handpainted stencil graphics directly onto the brickwork
right: aerial view and upclose view of the new shopfront features as a whole

Readdressing the iconic signage “Eel & Pie House” on the brickwork was part of the proposed work everyone was very keen to do, from planning officers to the freeholder. The existing plastic letters had worked with the large flood lights below, but both were in a poor state and weren’t in keeping with the host building. After testing several ideas, from hanging a traditional signboard, fixing fret cut satin brass letters back to painting directly on the brickwork several font options were then tested out. A simple but effective drop shadow design was agreed and careful hand painted using stencils to bring it to life and tie into the historic nature of the building.
