116 peckham high street

NAME **THE RED BULL**
DATES. 2017 - 2019
CLIENT. SOUTHWARK COUNCIL
SPONSER. HERITAGE LOTTERY FUND
MAIN
WORKS. **RESTORE**

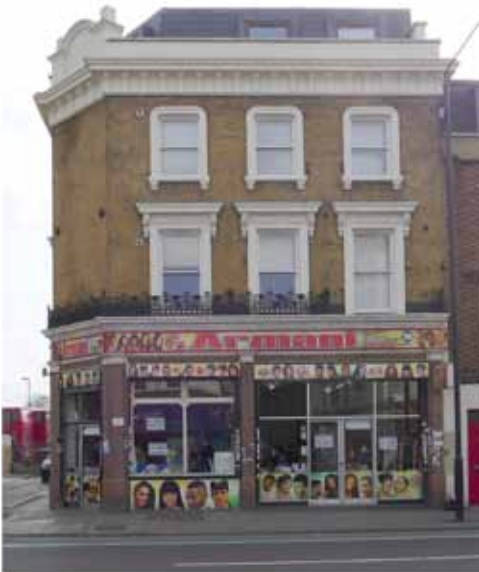
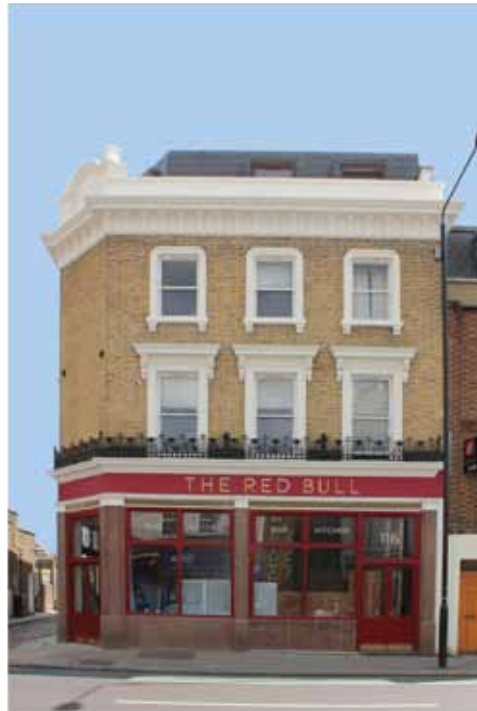
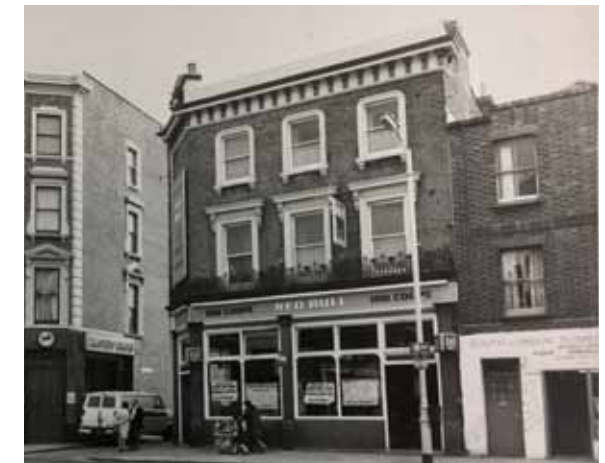
right: The Red Bull Public House in 1979 - Southwark Local History Library and Archive

left: 116 Peckham High Street in 2017 before works and in 2019 after works

For example, this SPAB principle was applied to the ground floor elevations with respect to the premise not functioning as a public house at this time. The 19th Century elevations were not exactly restored to prevent interference with a future use and help continue a retail use that is profitable and remunerative to its respective lessee. The result was a new shopfront that returned it as closely as possible to the original design and, by doing so, generated a more architecturally coherent arrangement of display windows and entrance doors that was sympathetic to the building's redecorated upper storeys.

The upper storey brickwork was carefully repaired "as found". A Doff cleaning, which is a specialist cleaning process was used. A 'DOFF' machine super-heats water to produce high-temperature steam. Once this was completed, the brickwork dried and excess dust and dirt brushed off sample patches of different lime mortar mixes were reviewed before a full repointing.

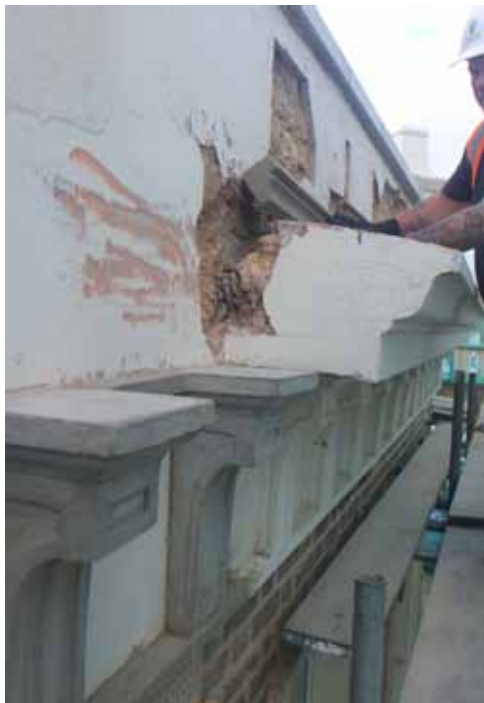
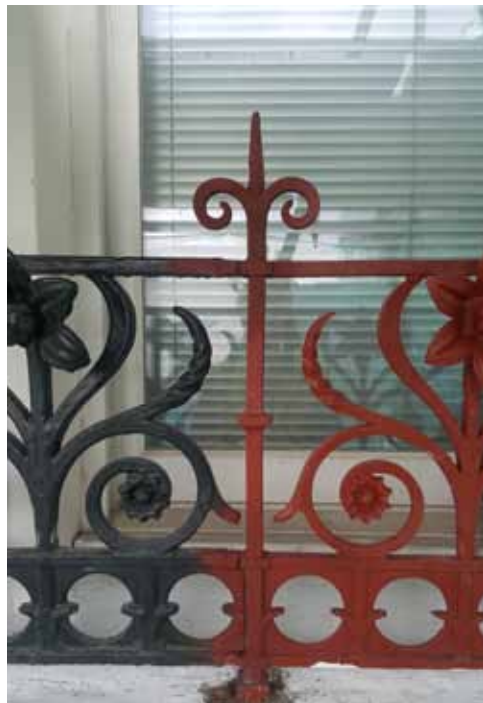
above: restoration works to the missing deep modillion cornice and brattishing section prior to redecoration works
right: replicating the frieze tiles and decoration works to the fascia

The only additions or alterations were the removal of untidy surface accretions and the replacement of sections or items of decoration that, if not replaced with matching items, would be perceived by the general public as being evidence of neglect or impoverishment. For example, the replacement of a missing section of cast iron brattishing above the ground floor cornice, the deep modillioned second floor cornice and a small but delicate tile frieze that was heavily damaged and missing from the side return elevation. Using a squeeze mold, each replica was then handmade with traditional methods.

Redecoration of the various items executed in render applied as "stucco" in imitation of dressed masonry respected the design intention to imitate stone either as ashlar or carved work. Stridently coloured or over-elaborate painting schemes were not considered. The new shop front sections were painted a deep red, whilst the stall risers clad with balmoral granite to match the existing arrangement. The new brattishing was painted in black to match existing and all the new cornices to side elevation matched existing.
