## 130 peckham hill street

NAME	<b>SULTAN BEIRUT</b>
DATES	2017 - 2019
CLIENT	SOUTHWARK COUNCIL
SPONSER	HERITAGE LOTTERY FUND
MAIN	
WORKS	<b>RESTORE</b>
	PARAPET CORNICE
	CAST IRON GRILLE
	TIMBER SHOPFRONT
	TIMBER WINDOWS
	STONE PILASTERS
	<b>CONSERVE</b>
	STONEMWORK CORNICE
	<b>REPAIR</b>
	SLATE ROOF
	<b>REDECORATE</b>
	STONEMWORK
	SHOPFRONT
	<b>DECLUTTER</b>
	PILASTERS FROM SIGNAGE
	CABLES AND PARAPHERNALIA

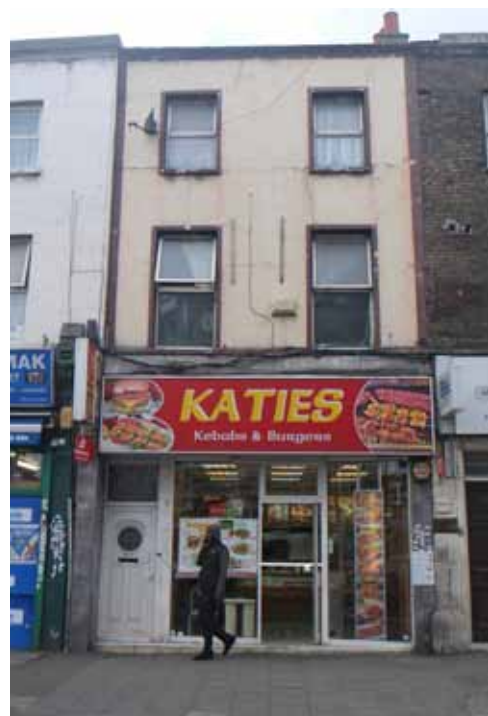
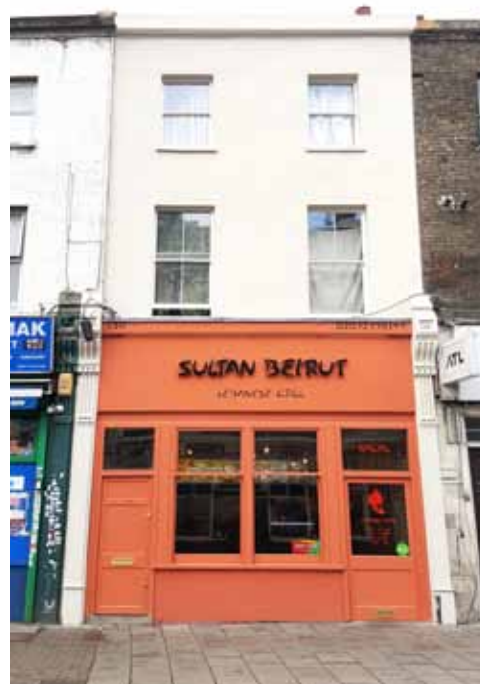
**left:** 130 Peckham Hill Street in 2017 before works and in 2019 after works

As part of the Peckham THI in 2017 and a comprehensive package of repair and restoration works was put forward to improve the condition and restore its visual appearance in line with neighbouring properties. This included reinstating lost and damaged historical features with the aim to bring back some of the unifying features that impart architectural clarity to the Shard Terrace. The works proposed intended to have no adverse or restricting effects, yet support its stakeholders to maintain and invest into the historical fabric for future longevity.

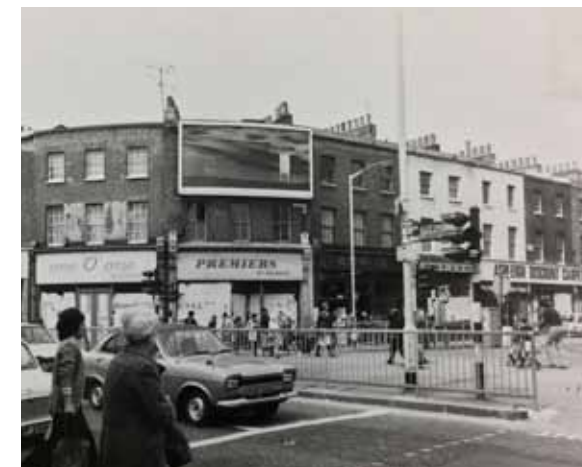
**right:** "The Shard Terrace" in 1979 - Southwark Local History Library and Archive

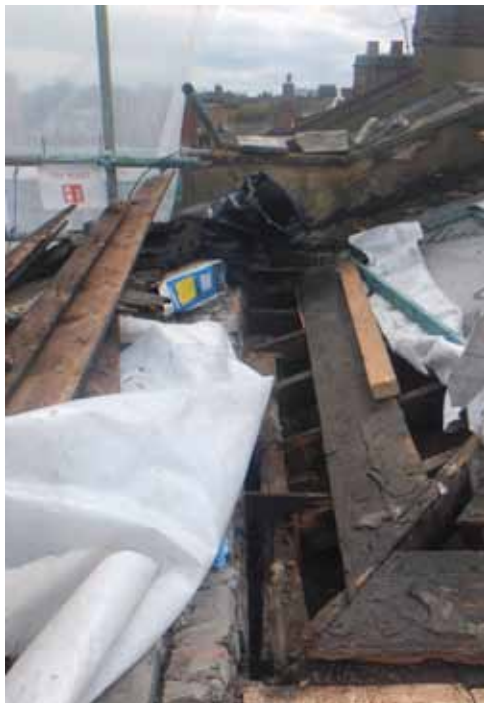
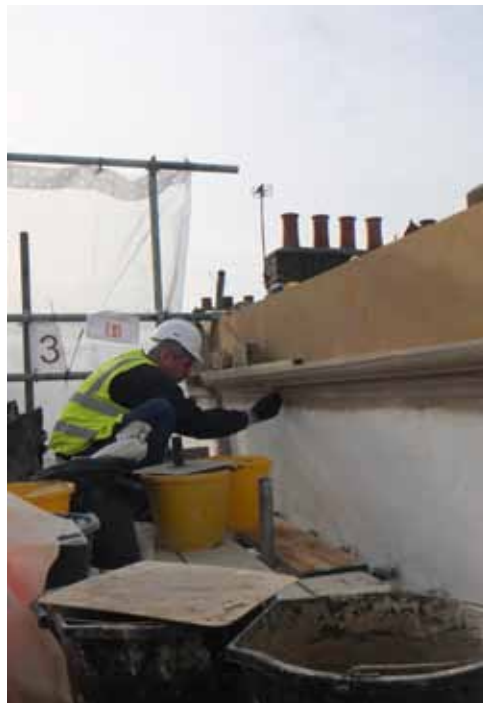
The parapet which had been removed at some stage before 1979 had doubly exposed the cornice to the vagaries of weather and "freeze-thaw" cycles in cold conditions. It had contributed to the evident deterioration of this feature and the roof. Whilst in the

**above:** exposing the roof condition behind the parapet and restoration works to the upper cornice  
**right:** a victorian coping stone detail and new replicated victorian shopfront details

Once on site the front elevation which was coated over during the 20th Century in a render consisting of at least two coats of cement mortar was removed. The addition of this cement render had denied the conservation effort to practically restore the bonded stock brickwork to its original appearance. The brick faces were irretrievably damaged by the mechanical bond between the render and the brick surfaces. A new render and finish was procured from the well-proven family of "water-glass" based repair materials that are the proprietary products of Keim Mineral Paints. These are durable and highly resilient due to being based on the chemistry of potassium silicate which will allow the brickwork to breathe naturally.

process of removing the coping stones, it exposed Victorian costing cutting approaches, using graveyard artefacts. The roof covering was extensively repaired and upgraded with new slate tiles, lead flashing and the upper cornice was repaired by implementation of the technique of applying successive thin layers of render of ever sharper definition using a "horsed" mould run on levelled rails.
