Peckham’s Historic Buildings Restored to their Former Glory

It’s thrilling to report that five more buildings within Peckham town centre have now been repaired and restored through Phase 2 of the Peckham Townscape Heritage Initiative (THI).

116 peckham high street

119 peckham high street

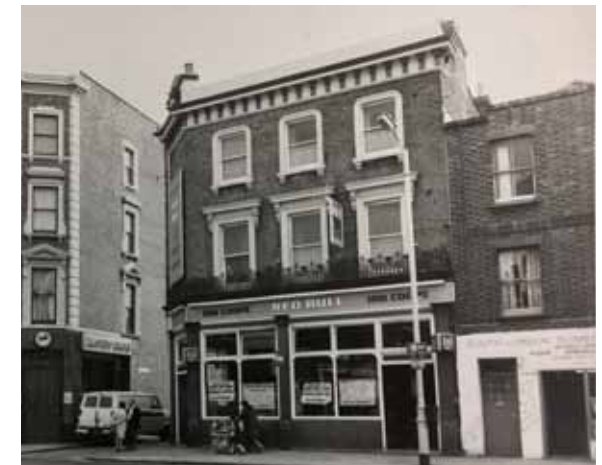
For example, this SPAB principle was applied to the ground floor elevations with respect to the premise not functioning as a public house at this time. The 19th Century elevations were not exactly restored to prevent interference with a future use and help continue a retail use that is profitable and remunerative to its respective lessee. The result was a new shopfront that returned it as closely as possible to the original design and, by doing so, generated a more architecturally coherent arrangement of display windows and entrance doors that was sympathetic to the building's redecorated upper storeys.

The upper storey brickwork was carefully repaired "as found". A Doff cleaning, which is a specialist cleaning process was used. A 'DOFF' machine super-heats water to produce high-temperature steam. Once this was completed, the brickwork dried and excess dust and dirt brushed off sample patches of different lime mortar mixes were reviewed before a full repointing.

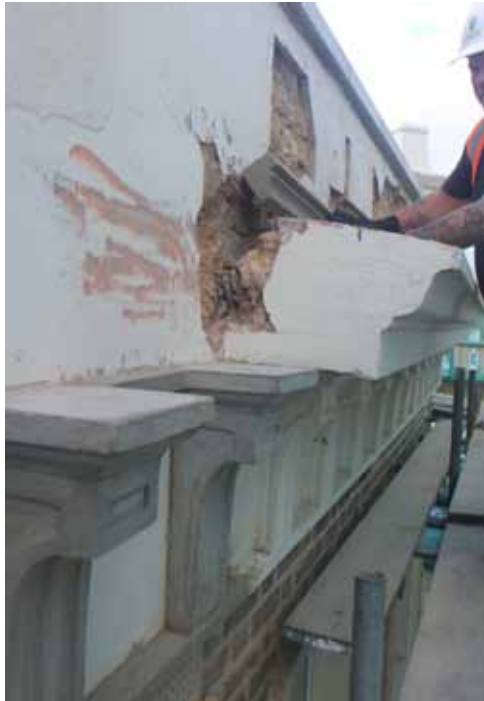
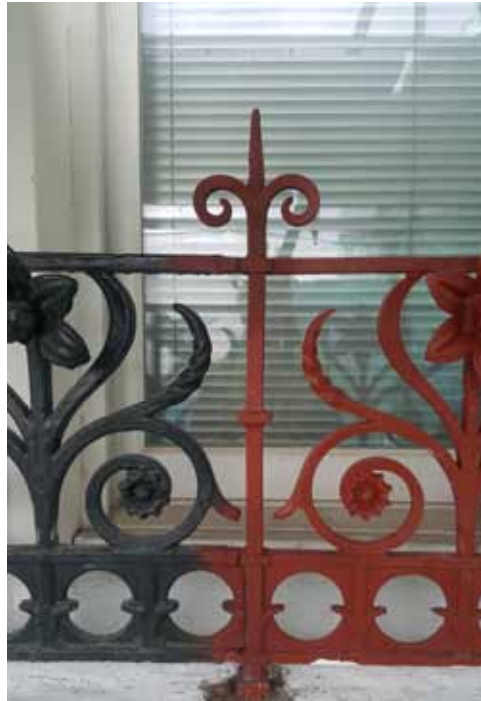
above: restoration works to the missing deep modillion cornice and brattishing section prior to redecoration works
right: replicating the frieze tiles and decoration works to the fascia

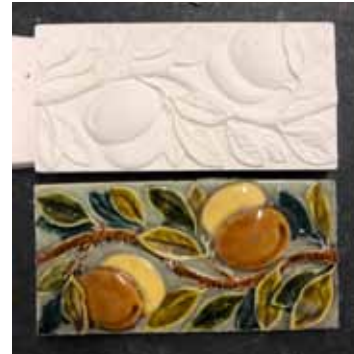
The only additions or alterations were the removal of untidy surface accretions and the replacement of sections or items of decoration that, if not replaced with matching items, would be perceived by the general public as being evidence of neglect or impoverishment. For example, the replacement of a missing section of cast iron brattishing above the ground floor cornice, the deep modillioned second floor cornice and a small but delicate tile frieze that was heavily damaged and missing from the side return elevation. Using a squeeze mold, each replica was then handmade with traditional methods.

Redecoration of the various items executed in render applied as "stucco" in imitation of dressed masonry respected the design intention to imitate stone either as ashlar or carved work. Stridently coloured or over-elaborate painting schemes were not considered. The new shop front sections were painted a deep red, whilst the stall risers clad with balmoral granite to match the existing arrangement. The new brattishing was painted in black to match existing and all the new cornices to side elevation matched existing.

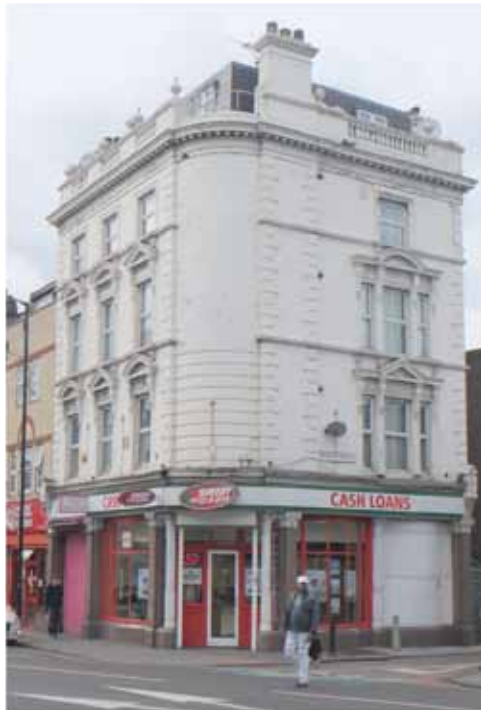
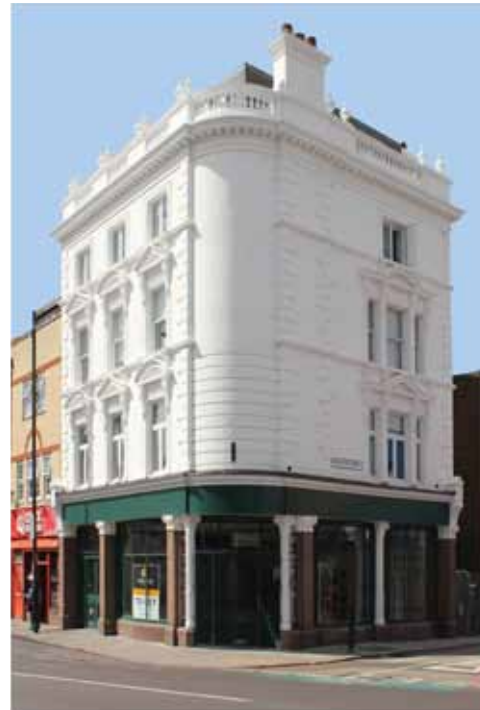
right: The Crown Public House in 1905 - Southwark Local History Library and Archive
left: 119 Peckham High Street in 2017 before works and in 2019 after works

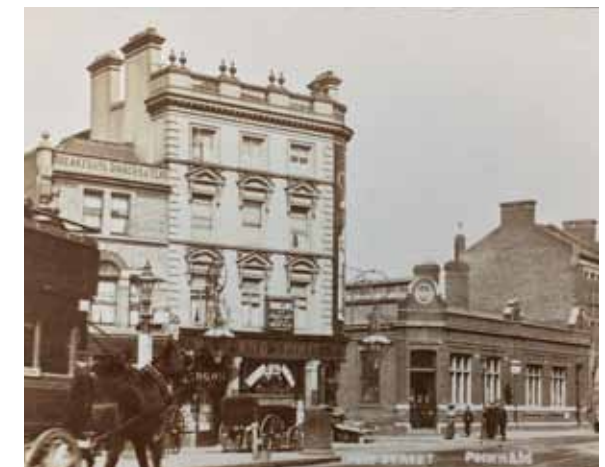
For example, this SPAB principle was applied to the heavily modelled, richly ornamented upper facades which asserted the buildings presence on the main street. The condition of the modillioned upper cornice and elaborate parapet balustrade ornamented with urns was visibly incomplete and 'quick fix' methods had considerably altered its appearance. By removing these interventions and repairing or replacing missing urns and baluster bottles it re-established the grandeur nature of this part of the building whilst respecting the fourth floor roof top extension.

The pediment window surrounds on this building are both strident and distinctive, as are the rusticated quoins on the corners. The condition of them had been affected by damp emanating from defective flashings and several layers of paint which had allowed water to expand and contract creating several defects. Before the facades were redecorated, all the defective fabric behind the paint was repaired and

made weather-tight. Infilling mortars used was Keim Spachtel. At the same time, new sash and casements windows were fabricated to fit carefully into debricked openings. Together the final arrangement better reflects the elegance of the facades distinctive architectural features. A reinstatement of a gate to the corner elevation replaced an ad hoc external shutter. There was a gate prior to this when looking back at the historical pictures. However, as we didn't have any more detail on the historical gates, we simply made them look unobtrusive and curved to suit.

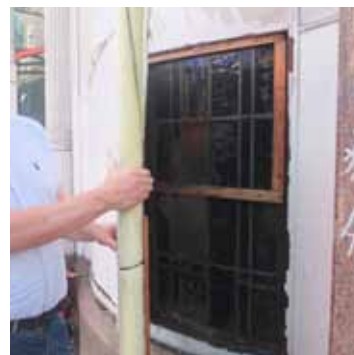
A new timber shop-front and entrance door to the corner of the building was fabricated to suit the original proportions of the existing timber windows to the main and side streets. Once on site, the far end shopfront window was uncovered for the first time and a damaged but surviving stain glass detail was found. This was used to prepare replica design & wording for new stained glass panels which several residents and other members of the public have developed great affection and regard for.

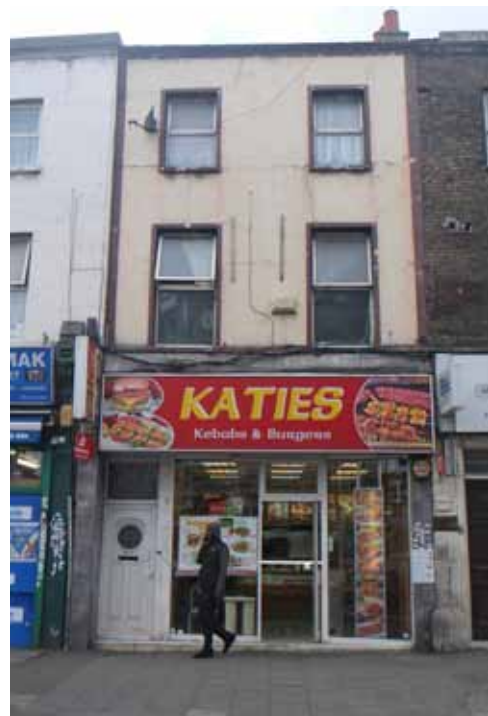
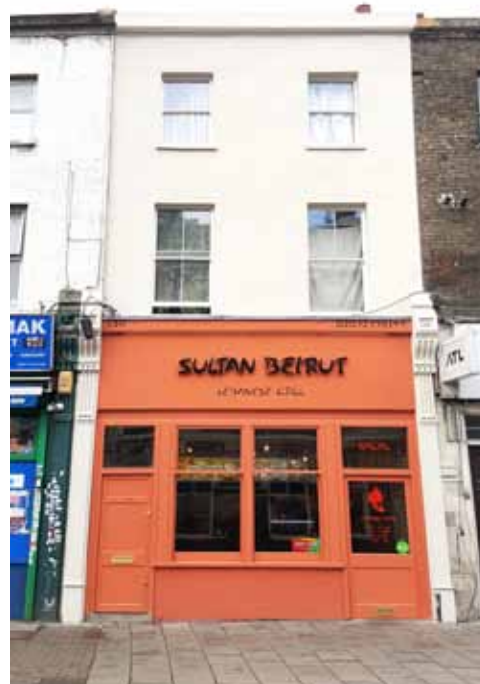
right: "The Shard Terrace" in 1979 - Southwark Local History Library and Archive

left: 130 Peckham Hill Street in 2017 before works and in 2019 after works

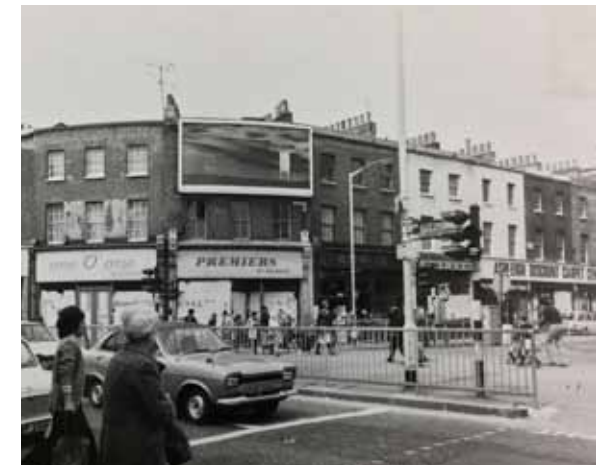
Once on site the front elevation which was coated over during the 20th Century in a render consisting of at least two coats of cement mortar was removed. The addition of this cement render had denied the conservation effort to practically restore the bonded stock brickwork to its original appearance. The brick faces were irretrievably damaged by the mechanical bond between the render and the brick surfaces. A new render and finish was procured from the well-proven family of "water-glass" based repair materials that are the proprietary products of Keim Mineral Paints. These are durable and highly resilient due to being based on the chemistry of potassium silicate which will allow the brickwork to breathe naturally.

The parapet which had been removed at some stage before 1979 had doubly exposed the cornice to the vagaries of weather and "freeze-thaw" cycles in cold conditions. It had contributed to the evident deterioration of this feature and the roof. Whilst in the

process of removing the coping stones, it exposed Victorian costing cutting approaches, using graveyard artefacts. The roof covering was extensively repaired and upgraded with new slate tiles, lead flashing and the upper cornice was repaired by implementation of the technique of applying successive thin layers of render of ever sharper definition using a "horsed" mould run on levelled rails.

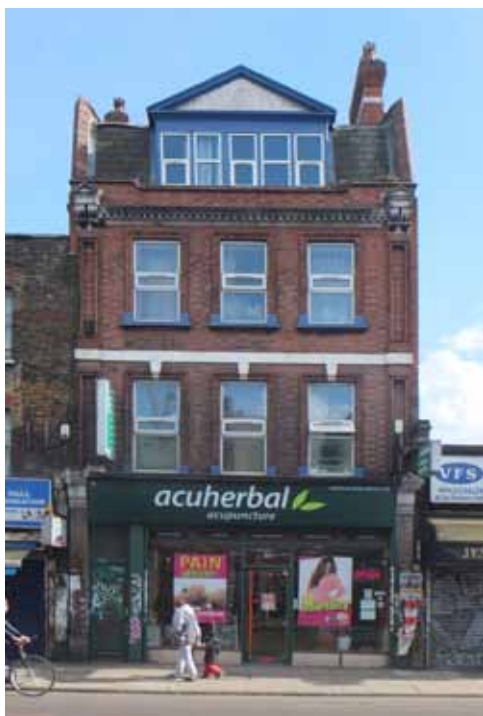
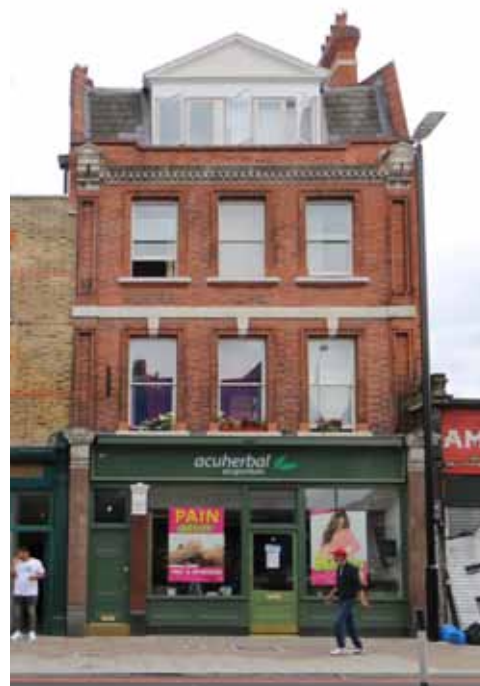
right: 86 Peckham High Street in 1979 - Southwark Local History Library and Archive

left: 86 Peckham High Street in 2017 before works and in 2021 after works

The original granite pilasters had been drilled into with defunct fixings, the Portland stone console brackets were broken and fractured by a doubled up projecting roof. The brickwork facade was sooted and the sills were unsuitably decorated. The recognisable stone band with adjoining key stones separated six large apertures, yet the sash windows had all been replaced with inappropriate pvc equivalents. Finally, a separate residential access was on the whole in a very poor condition to welcome anyone home warmly.

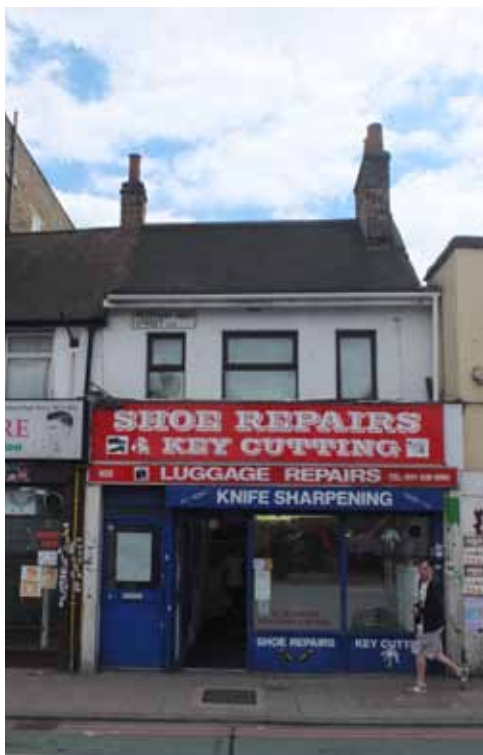
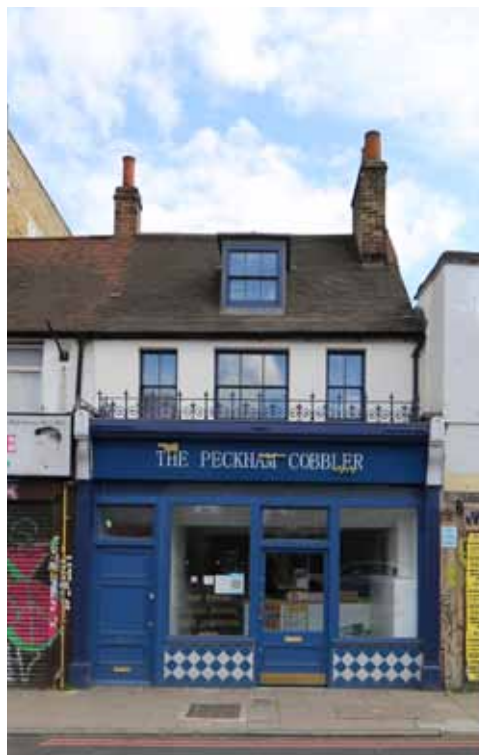
In 2018 we observed the front elevation of the property was severely degraded and architecturally diminished compared to its appearance in the earliest of the surviving historical photographs dating abck to 1928. However, a later 1945 photograph provides some explanation for the loss of original distinctive features and ornament. The shattered shop front at street level is almost certainly the consequence of war-time bomb blast damage and a subsequent shopfront was installed. The photograph also shows that the shop has been incorporated into the retail area of the neighbouring premises up to number 106. The three shops were amalgamated into one trading outlet, such that it had become an annexe to the main business premises there. In this way later on when relinquished from this, there was no effort or expense devoted to restoring the decorative features of the original shop-front as seen in photograph taken in 1979.

left: 102 Peckham High Street in 2019 before works and in 2021 after works

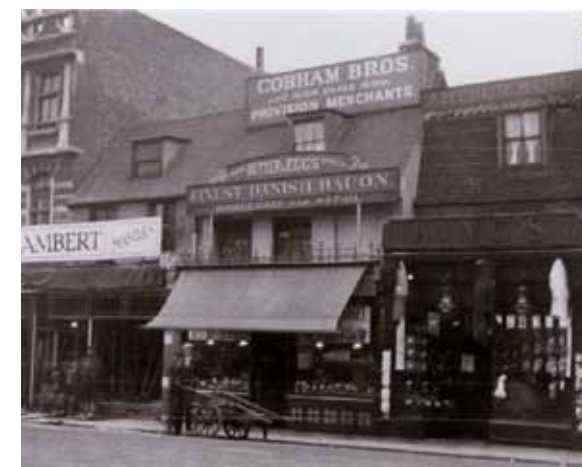
The recent condition to keep the building functioning had been entirely pragmatic and utilitarian. As a result, we addressed releveling the adjusted eaves level surface water drainage from the roof, the reinstatement of the dormer and timber pilaster heads, redecoration of the cement render, complete overhaul of the projecting roof top and drainage.

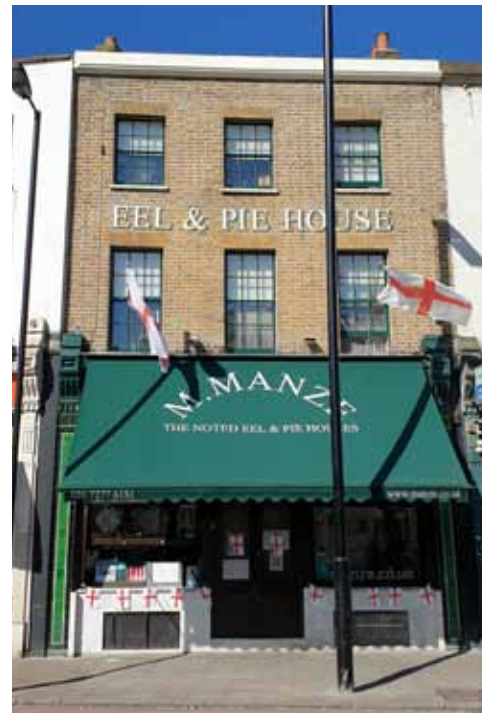
left: 105 Peckham High Street in 2019 before works and in 2021 after works

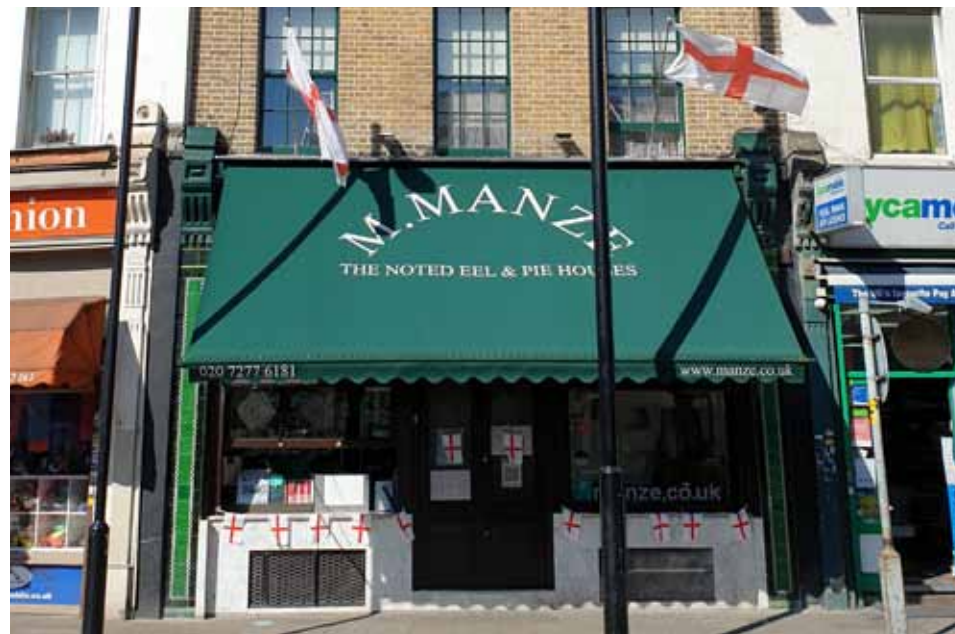
above: reinstatement of new signage using handpainted stencil graphics directly onto the brickwork
right: aerial view and upclose view of the new shopfront features as a whole

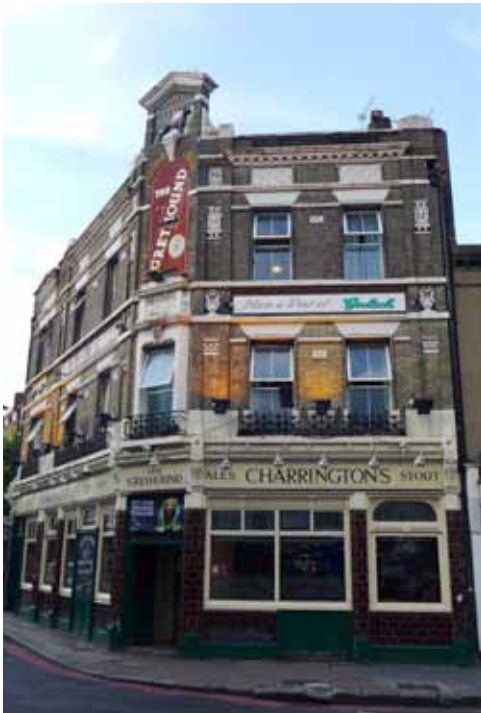
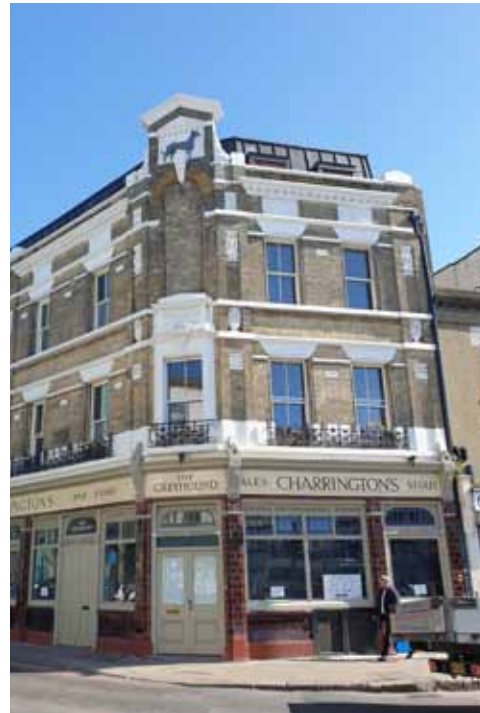
Like many pubs the different management teams, supplier advertisement schemes and night time illumination had cluttered the facade and peppered it with a number of defunct fixings and paraphernalia. Alongside this, the brickwork and stone work where in a moderately poor condition in places and several missing details which had been long forgotten about as they really could only be seen on close up inspect.

A detailed existing conditions survey helped to establish a outline principle on which areas of the facade could be repaired, repointed and in some circumstances would require bricks replaced in full

to match due to the extent by which it was likely to be damaged beyond repair once the removal of the defunct fixings had been done.

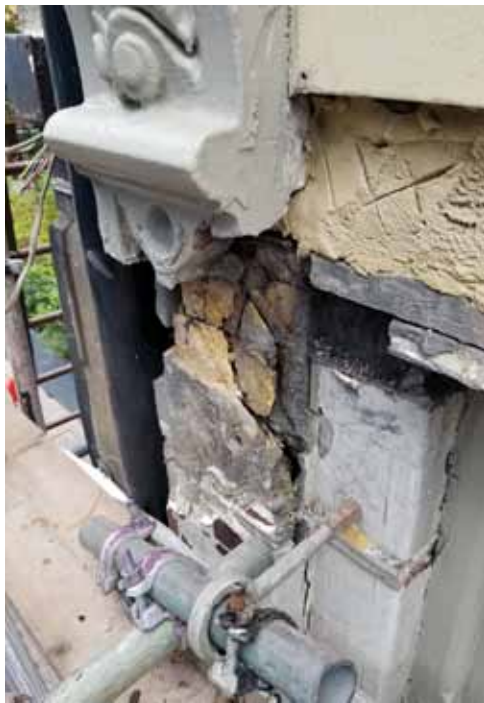
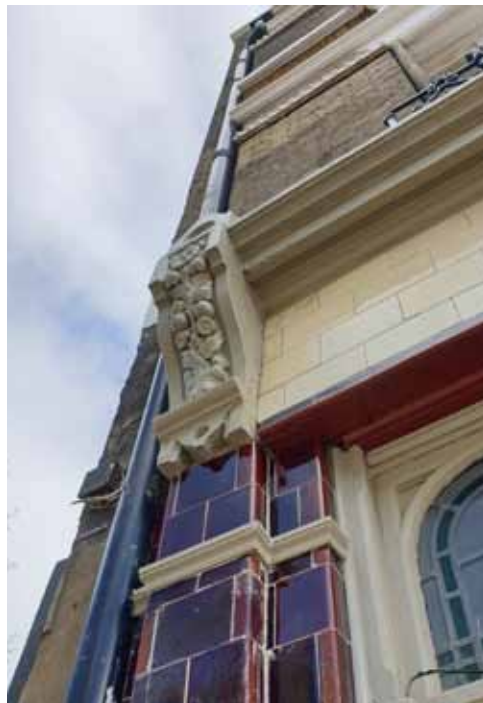
Further close up investigations of the existing tile work at lower level also revealed the need for more extensive opening up works as fractures in the pilaster face indicated the movement of it away from the building fabric was due to larger underlying problems. These opening works concluded it was not a structural issue and was due to failing patched render attempts over the years. As a result, stripping back and restructuring the backing and facing with match tiles restored the fine details to this part of the facade and reduced any risk to the general public.

above: investigation works to the missing pilaster head and face prior to redecoration and tile works
right: replicating the fascia tiles and decoration works to the lead windows

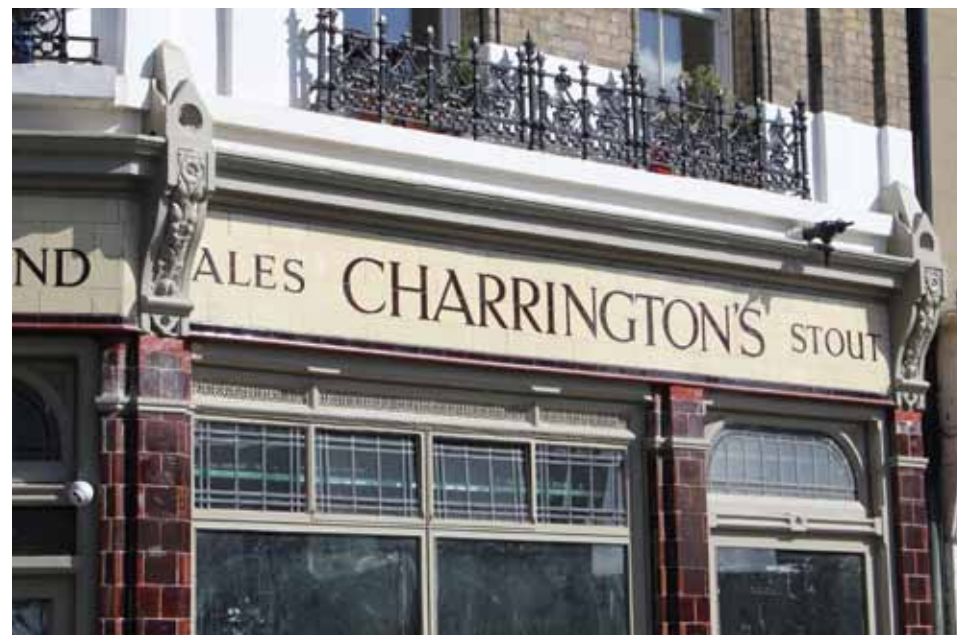
Following the success of the stain glass restoration work in phase 1, we reused the same subcontractor to undertake the restoration of the simple yet striking stain glass fan lights that were above the ground floor windows. There was several fanlight panes that were broken and disfigured with vents, ad-hoc repairs and as result required careful remediation and replacement off site. Once brought back to site they looked as if they had always been in such great condition which added to the property's mystique.
