119 peckham high street

NAME **THE OLD CROWN HOTEL**

DATES 2017 - 2019

CLIENT SOUTHWARK COUNCIL

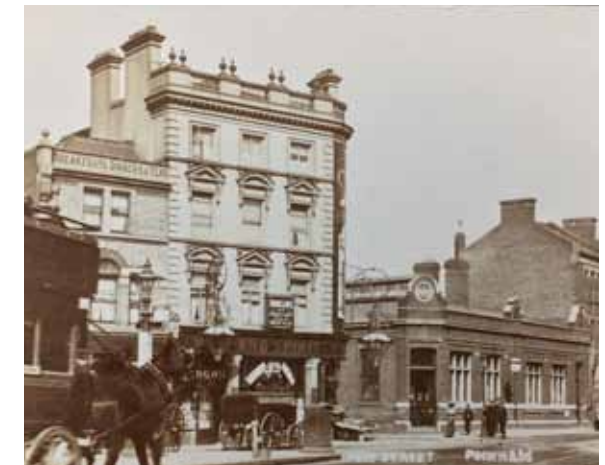
For example, this SPAB principle was applied to the heavily modelled, richly ornamented upper facades which asserted the buildings presence on the main street. The condition of the modillioned upper cornice and elaborate parapet balustrade ornamented with urns was visibly incomplete and 'quick fix' methods had considerably altered its appearance. By removing these interventions and repairing or replacing missing urns and baluster bottles it re-established the grandeur nature of this part of the building whilst respecting the fourth floor roof top extension.

above: restoration and redecoration works to the parapet balustrade finials and stucco facade painting stripping
right: replicating the shopfront leaded light window pane details upon discovery of original artefacts

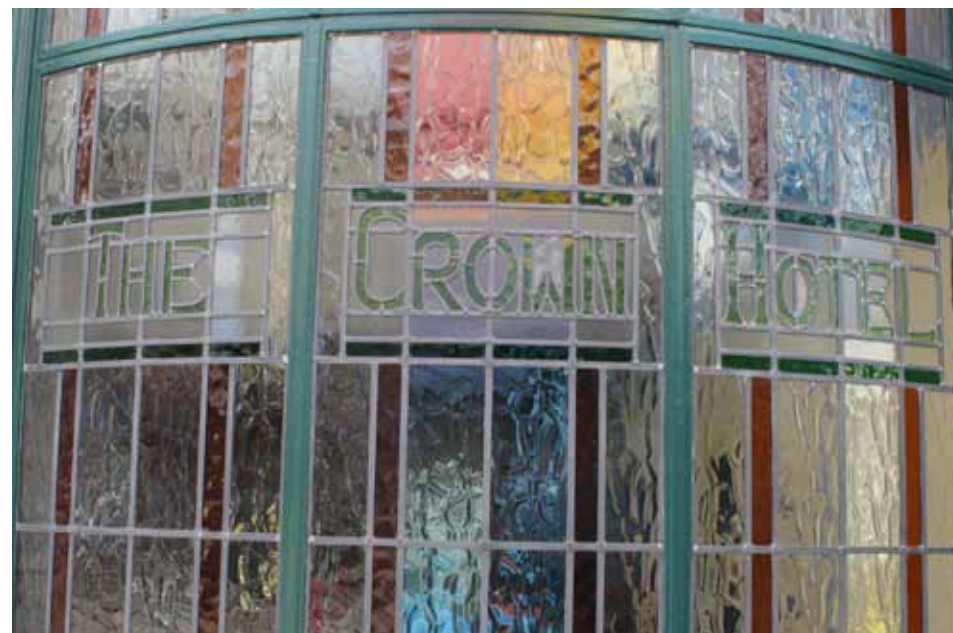
“ **The condition of the salvaged stain glass showed it had already been repaired and fixed since its original conception. We were able to identify the original details and replicate them in new panels which will last longer than partial repairs”**

A new timber shop-front and entrance door to the corner of the building was fabricated to suit the original proportions of the existing timber windows to the main and side streets. Once on site, the far end shopfront window was uncovered for the first time and a damaged but surviving stain glass detail was found. This was used to prepare replica design & wording for new stained glass panels which several residents and other members of the public have developed great affection and regard for.
