## 86 peckham high street

NAME: **ACUHERBAL**  
DATES: 2018 - 2021  
CLIENT: SOUTHWARK COUNCIL  
SPONSER: HERITAGE LOTTERY FUND  
MAIN  
WORKS: **RESTORE**

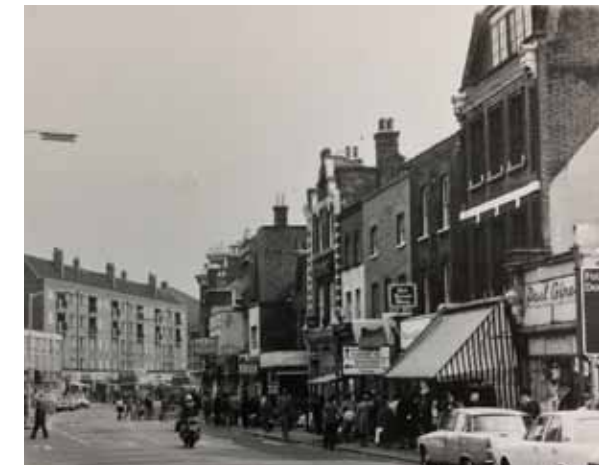
As noted in the area assessment of Peckham undertaken by English Heritage in 2009 the south side of Peckham High Street is more vernacular in character and has retained a great amount of earlier development. By 2018, various inappropriate additions, clutter and disrepair crowded the facade of this impressive property and was reducing the splendour of many of its historical design features.

The original granite pilasters had been drilled into with defunct fixings, the Portland stone console brackets were broken and fractured by a doubled up projecting roof. The brickwork facade was sooted and the sills were unsuitably decorated. The recognisable stone band with adjoining key stones separated six large apertures, yet the sash windows had all been replaced with inappropriate pvc equivalents. Finally, a separate residential access was on the whole in a very poor condition to welcome anyone home warmly.

To begin with on site the sturdy and well-modelled front elevation brickwork was gently cleaned using the 'DOFF' machine to super-heat water to produce high-temperature steam. This was a delicate operation because of the Flemish bond and bordering features. The panelled brickwork pilasters have "cut and-rubbed" moulded borders were lots of dirt and soot had built up over the years. At the same time careful cleaning to the top of these borders, a pair of carved Portland stone capital consoles and a supporting pediment at the gable parapet.

Further down, the plain stone band and the head of the first floor window keystones were stripped of flaking paint alongside the blue sills and corner stones using nonabrasive cleaning. Where necessary, delicate repairs to the stonework was undertaken by a suitably experienced and expert specialist to use a crack stitching method which is invisible once installed and therefore did not disrupt the aesthetic
