88 peckham high street

NAME	MAMA
DATES	2018 - 2021
CLIENT	SOUTHWARK COUNCIL
SPONSER	HERITAGE LOTTERY FUND
MAIN	
WORKS	RESTORE
	BRICKWORK
	TIMBER WINDOW FRAMES
	HANGING SIGN
	PILASTER FACE/PEDESTALS
	CONSERVE
	PILASTER HEADS
	GAUDGED LINTELS
	REPAIR
	PITCHED ROOF
	LEADWORK + DRAINAGE
	REDECORATE
	SILLS
	SHOPFRONT
	DECLUTTER
	CABLES AND PARAPHERNALIA

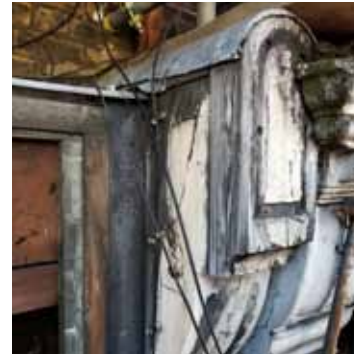
Structural repair undertaken within the last 30 year to stabilise the front wall and parapet has disfigured the main elevation by disrupting the intended pattern, surface colour, texture and bond of the facing brickwork. Cement mortar, which does not permit release of water-vapour from backgrounds, has been used to bed and joint brickwork in these recent repairs. As a result after undertaking a close up brickwork survey it was returned to a state where the facing brickwork was consistent and entire. Cement mortar was carefully cut out and replaced with "vapour-open" bedding and jointing mortar made with a lime binder. However, the pattress plate for the steel tie was retained as this constitutes evidence of what has happened to the building over time.

“ **Cement mortar is to be carefully cut out...however, the pattress plate for the steel tie will remain as this constitutes evidence of what has happened to the building over time.**”
